Annual Inspection Report of the Play & Sports facilities at
Pollards Moor Road, Copythorne

Copythorne Parish Council

15th May 2019

Copythorne Parish Hall Play & Sports facilities

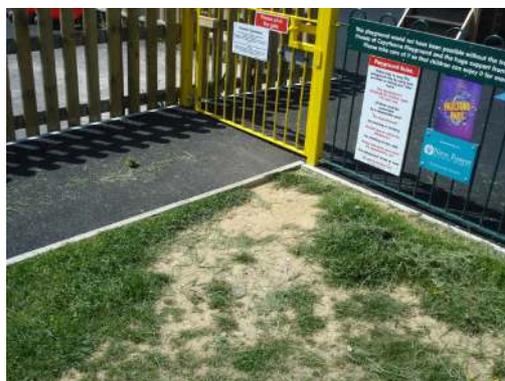
photo 1

Soil erosion abutting the PCC edging creating a trip hazard (this is partially due to wheel & push chair users having to step aside the gate arc to gain access). *Make up flush with topsoil & re-grass in the appropriate season, if erosion & puddles remain a problem, consider slabs, grass reinforcement mats mats laid on mesh/geotextile material on an even surface, chased into the soil at the edges to avoid sharp gradients (<1:5) & trip zones is suggested or other durable surface (photo 1).* Medium risk

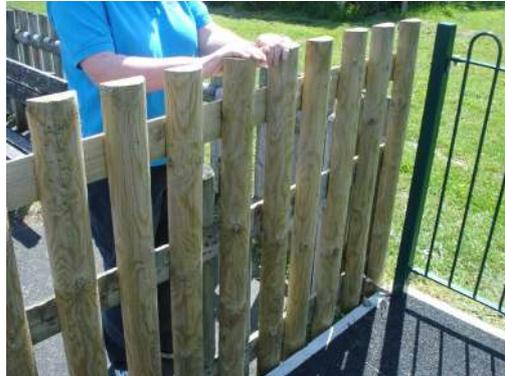
photo 2

Several sharp nail points projecting from the original timber fence rail abutting the play area. *File/knock down flush to timber (photo 2).*
