## **COPYTHORNE PARISH COUNCIL MEETING - TUESDAY 13<sup>TH</sup> OCTOBER 2020**

### **ITEM NO: 11 – Playground Inspection – Operational Inspection Report / Summary of members Visual Inspections**

Annual Inspection Report of the Play & Sports facilities at  
Pollards Moor Road, Copythorne

4th August 2020

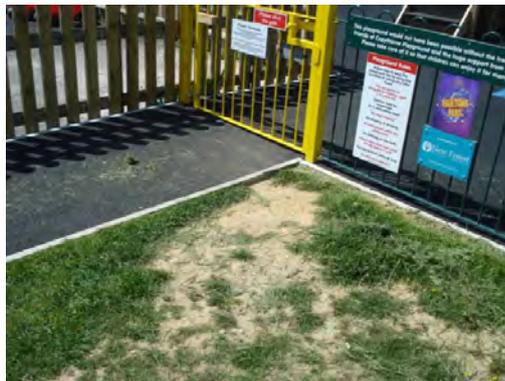
photo 1

Soil erosion abutting the PCC edging creating a trip hazard (this is partially due to wheel & push chair users having to step aside the gate arc to gain access). *Make up flush with topsoil & re-grass in the appropriate season, if erosion & puddles remain a problem, consider slabs, grass reinforcement mats laid on mesh/geotextile material on an even surface, chased into the soil at the edges to avoid sharp gradients (<1:5) & trip zones is suggested or other durable surface (photo 1).* Medium risk

1. Access Pathway – Soil Erosion creating a Trip Hazard *Issue was initially resolved by the use of undersoil strengthening and ground levelling. However, some further erosion is noted, but it is believed that the new bicycle racks when installed will help 'deflect' the traffic and relieve the pressure on a strip of ground by the gate*

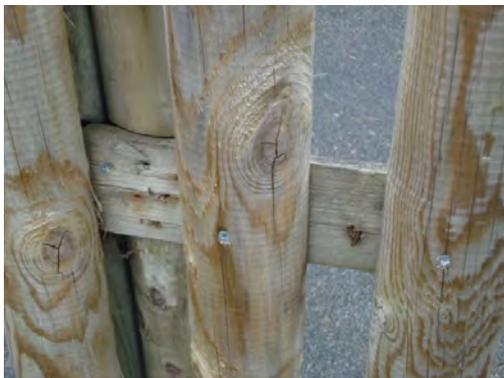
photo 2

Several sharp nail points projecting from the original timber fence rail abutting the play area. *File/knock down flush to timber (photo 2).*

4. Fencing - sharp nails projecting from original timber fence – *Nails were removed but the Inspector has managed to find a new one which needs to be dealt with!*

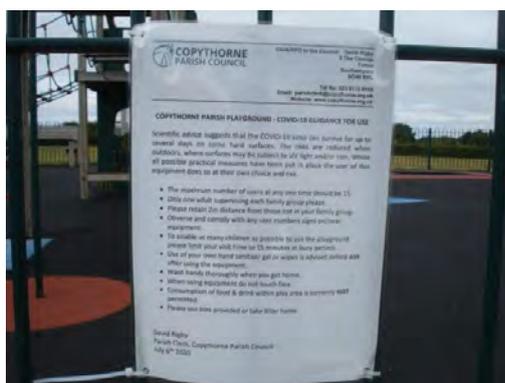
photo 3

(i) attached to fence complete with contact details (4) (photo 3).

Signs on gates are not recommended as in windy conditions they can alter the closure rate.

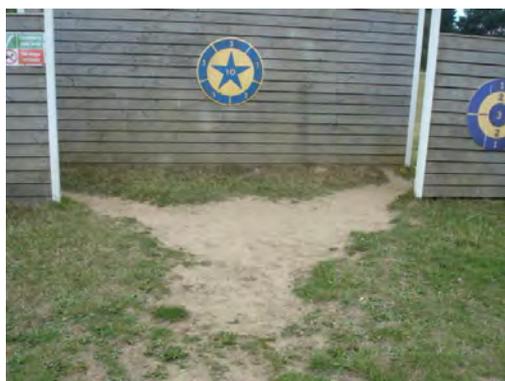
photo 4

# *Make up playing surface level & flush with topsoil & re-grass in the appropriate season, if erosion & puddles remain a problem, programming for the provision of a durable artificial surface recommended for consideration (photo 4).*

# Pedestrian traffic worn route through to the field behind the MUGA. *Monitor for sports balls conflicting with persons using the through route/consider providing a completely separate access (photo 4).*

7. **MUGA:** See (5) above. We were going to fit anti-cycle bars, but we are now considering alternative locations for the wall. The reasoning is that it is also causing some (accidental) issues with balls going into the playground. In addition we are working with the Parish Hall Committee on a resolution to the field access which is via the MUGA opening – hence the high degree of wear in this area (those playing on the MUGA tend not to be standing right in front of it and the wear is actually to do with the field access). [A current through route problem highlighted in the Report on page 4.](#)
