COPYTHORNE PARISH COUNCIL MEETING – MARCH 9TH 2021

ITEM NO: 12 – Playground Inspection – Operational Maintenance Inspection Report / Summary of members Visual Inspections

Operational Maintenance Inspection Report of the Play & Sports facilities
at Pollards Moor Road, Copythorne

4th February 2021

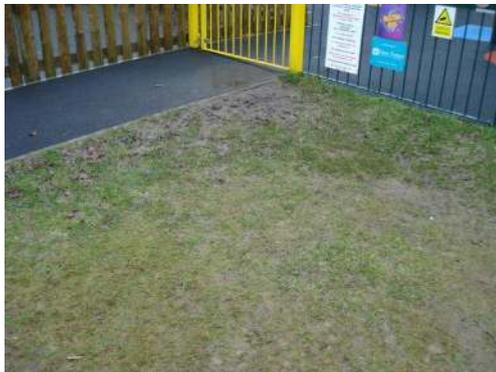
photo 1

1. Access Pathway – Soil Erosion creating a Trip Hazard – Medium Risk *Make up flush with topsoil & re-grass in the appropriate season* **This work will form part of the recommendations detailed in Item 13 on today's agenda**

Soil erosion abutting the PCC edging creating a trip hazard (this is partially due to wheel & push chair user having to step aside the gate arc to gain access).

Make up flush with topsoil & re-grass in the appropriate season, if erosion & puddles remain a problem, the provision of slabs or a durable surface similar to play equipment grass mats laid on mesh/geotextile material on an even surface, chased into the soil at the edges to avoid sharp gradients (<1:5) & trip zones is suggested (photo 1). Medium risk

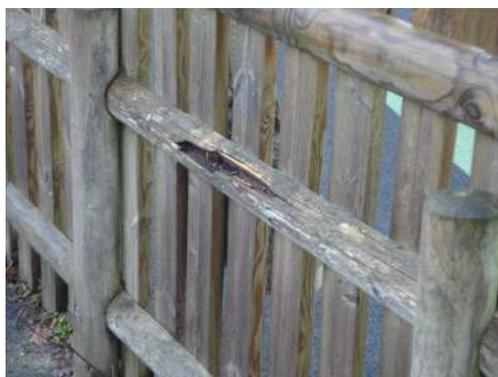
photo 2

2. Play area boundary fencing – Decayed timber – *Programme/budget to replace.* **This is a Parish Hall issue and they have been advised again to undertake this work.**

Some decay to the horizontal half round timber rails. Programme/budget to replace (photo 2).

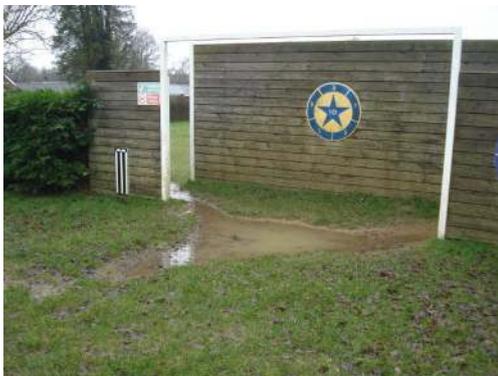
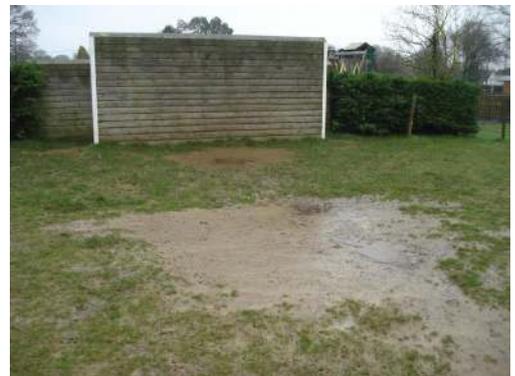
5. Multi Use Games Area – Excess erosion of playing surface (Soil and grass) – *Suggest an alternative route (separate gate) is provided to avoid the through route. Make up playing service level & flush with topsoil and re-grass in the appropriate season.* **This work will form part of the recommendations detailed in Item xx on today's agenda**

The inspection revealed advanced wear/erosion to the playing surface of the north eastern side of the ball screen, irrespective of the current puddling, has encouraged the south western side having a relatively even surface side to be used instead.

The erosion is made worse by the use of either gaps at the side of the ball screen as a route through to the playing field behind.

Excessive erosion of playing surface (soil & grass) partially to the north eastern side and made worse by footfall in the open pedestrian through route.

Suggest an alternative route (separate gate) is provided to avoid the through route.

Make up playing surface level & flush with topsoil & re-grass in the appropriate season, if erosion, ruts & puddles remain a problem, programme for the provision of a durable artificial surface is recommended for consideration (photos 3 & 4).
