Annual Inspection Report of the Play & Sports facilities at  
Pollards Moor Road, Copythorne

Copythorne Parish Council

24th August 2021

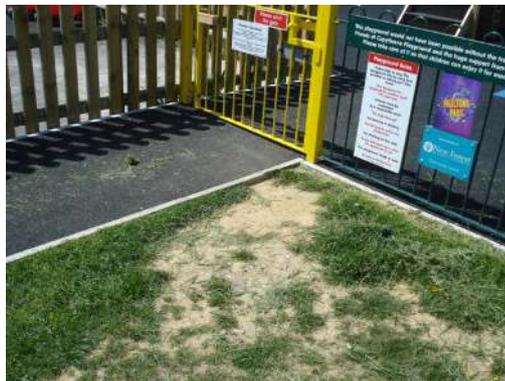
photo 1

Soil erosion abutting the PCC edging creating a trip hazard (this is partially due to wheel & push chair users having to step aside the gate arc to gain access). *Make up flush with topsoil & re-grass in the appropriate season, if erosion & puddles remain a problem, consider slabs, grass reinforcement mats laid on mesh/geotextile material on an even surface, chased into the soil at the edges to avoid sharp gradients (<1:5) & trip zones is suggested or other durable surface (photo 1).* Medium risk
