## Copythorne Parish Council – Tuesday December 10<sup>th</sup> 2019

### Item 17 – Chairman’s Report

#### COPYTHORNE PARISH HALL - DEALING WITH THE CURRENT ENTRANCE TO THE UPPER FIELD - ACCESS

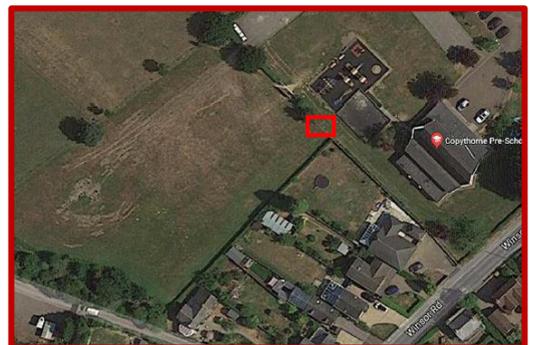
3. Create a new gated entrance to the upper field with appropriately reinforced (scalpings on matting covered in chippings or cinder) for pedestrian users; install a double gate of suitable design so that either a single or both gates can be opened depending on the volume of people at the event. The position for this would involve a new gap being created in the hedge / fence. See the image above for a proposed location. This would be a Parish Hall Committee item.
